### Smoke and Dye-Water Observation Summary

# Western Run Pilot Project - Baltimore Maryland

## **INSPECTION REPORT**

STREET: GLEN AVE. TEST 86 B 1 MAP #1: MH: 1521351 CITY: BALTIMORE MAP #2: MH: STUB MAIN RESIDENTIAL STREET LOCALE: TAPE #: JAM 2 TV'D LGTH: 28.37 ft

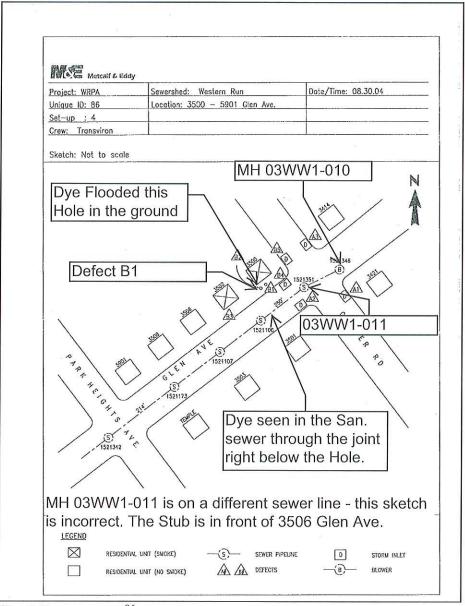
X\Baltimore City\Western Run Pilot Area - Data Files\Smoke Testing\Pictures\Sketches\86.tif

Englishing dodests		√ sati sesiikide	PARE RECHE	
1. POSITIVE	1. MAIN SEWER	5. DOWN SPOUT	9. STAIRWELL DRAI	13. STORM DRAIN
2. NEGATIVE	2. SERVICE LINE	6. DWNSPT CONN.	10. FOUNDATION DRAIN	14. CATCH BASIN
3. CANNOT TEST	3. TRANSITION JOIN .	7. AREA DRAIN	11. BUILDING INTERIOR	15. STORM MH
	4. CLEAN OUT	8. DRIVEWAY DRAIN	12. MH FRAME/SEAL	16. STORM DITCH
dditional Comments:	DYE SEE	N ATT 30	9/27, DI	RECTLY
BRLOW	i Hock	IN GRE	or us	<i>y</i>
			The second secon	
	A.J	dis Bretta
